Gas Turbine Components Life Extension Clinic

9FA 3RD STAGE BLADE EXTENDED TO 120,000 FFH

V94.3A4 2ND STAGE BLADE EXTENDED TO 75,000 EOH

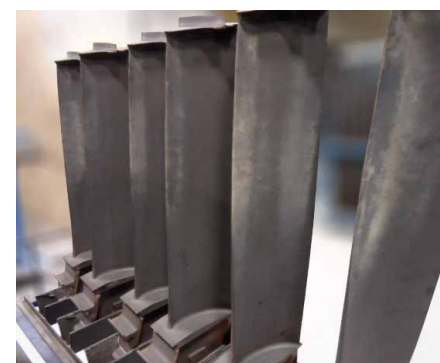
Observations indicated galling in root serrations and seal pin surfaces, as well as the presence of two distinct casting houses to produce the row of buckets.

Inspections showed that the manufacturer's heat treatment did not achieve full solutioning. All blades also displayed a two-phase gamma prime structure within each grain, indicating that the previous repair heat treatments were not optimized to achieve a good structure. In addition, the blades had surface oxidation and depletion. Even so, the components all were deemed repairable.

Additional repair work included grit blasting and polishing the gas path surfaces to remove an oxide layer, a complete X-ray inspection, and HVOF coating and diffusion to reduce surface degradation.

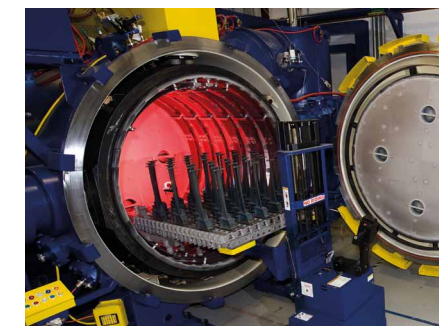
The test blades were evaluated to determine the material's response to the heat treatment. The material responded well to the heat treatment on the blades. The primary gamma transformed to a more cuboidal morphology, which provides for improved component creep life.

Repair heat treatment was applied to several samples from the test blades. Our experts utilize a vacuum heat treat furnace, where we control the heating and cooling of metals to alter their physical and mechanical properties.

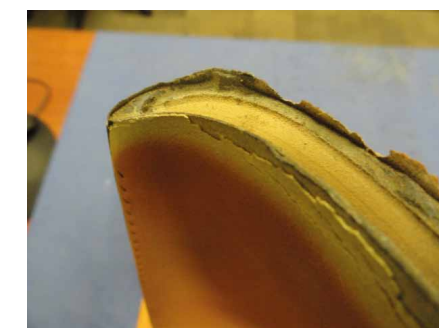
The external TBC appeared in good condition. However, the blade tip has significant oxidation. This is most likely due to the weld wire selected during the previous repair. All other inspections were normal.

confirmed that the heat treatment process will heal and improve the gamma prime structure.

Our experts performed a pre-weld heat treatment, post-weld heat treatment, and a diffusion or aging heat treat solution utilizing our vacuum heat treat furnace in our shop.

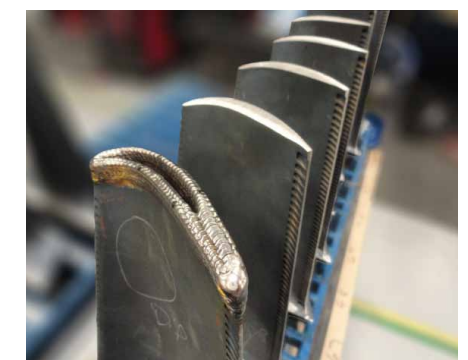
The measurements of the blade tip cap indicated that there was sufficient material to perform a successful weld build up repair, so they removed most of the previous weld repair. Because of heavy oxidation on the blade tip, an oxidation resistant alloy was used. Our weld repair procedure has demonstrated to provide excellent oxidation resistance during operation.

A coating system consisting of a NiCoCrAlY applied by HVOF and a TBC top coat was applied with our propriety coating. The V94.3A4 2nd Stage Blades' lives were extended to operate to a total of 75,000 EOH.
